Nestled behind Sacramento's Amtrak station and below the bridges of Interstate 5, almost out of sight from the townsfolk and Interstate motorist, lies the heart-beat of the Southern Pacific Railroad, the Sacramento Shops. Renamed the Sacramento Locomotive Works in 1981 to reflect the changes that have occurred over the years, the shops were once the largest employer in California's capitol city when over 5,000 workers maintained all of the system's locomotives, freight and passenger cars, and manufactured new cars and spare parts for them.

◆ Article by Don Bain — Photography by Dick Dorn ◆

Locomotive Flow Chart Thru GRIP Program And Shop Building Layout

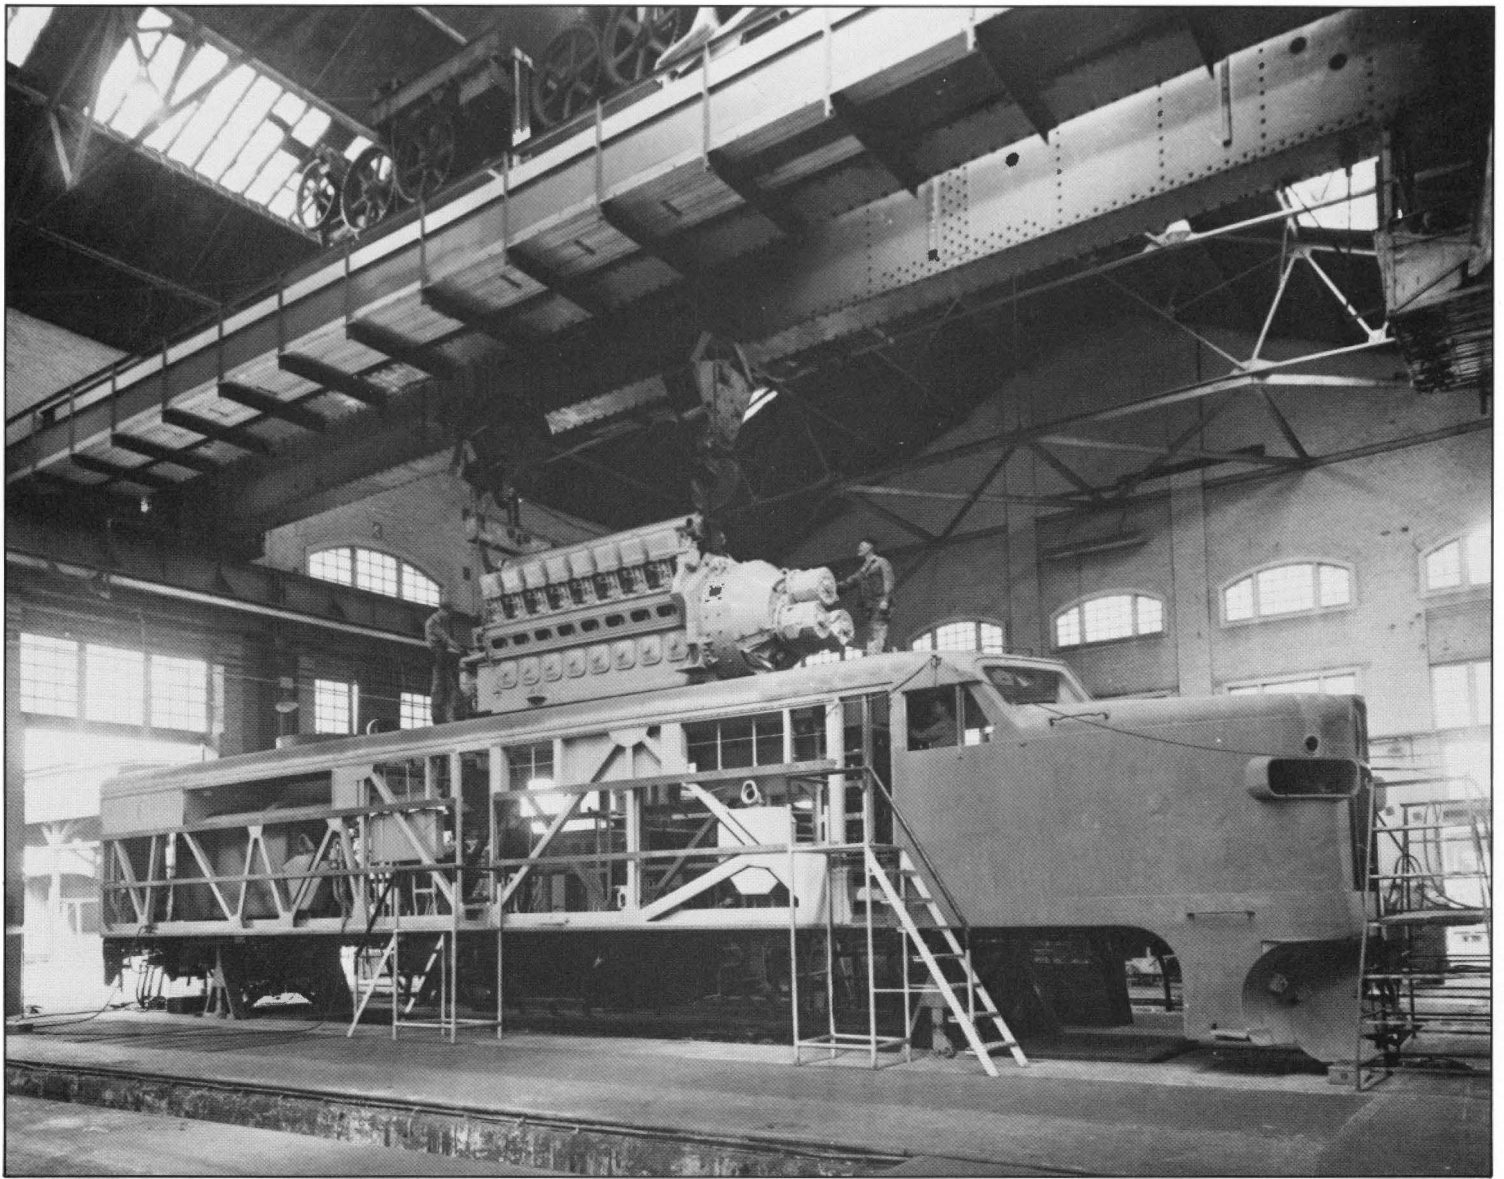
Alco PA-1 number 6006 was stripped and undergoing a Class A overhaul at the Sacramento Shops in September 1953 after 1,250,000 miles of service. This was the first PA to have a general overhaul on the SP. *Southern Pacific*

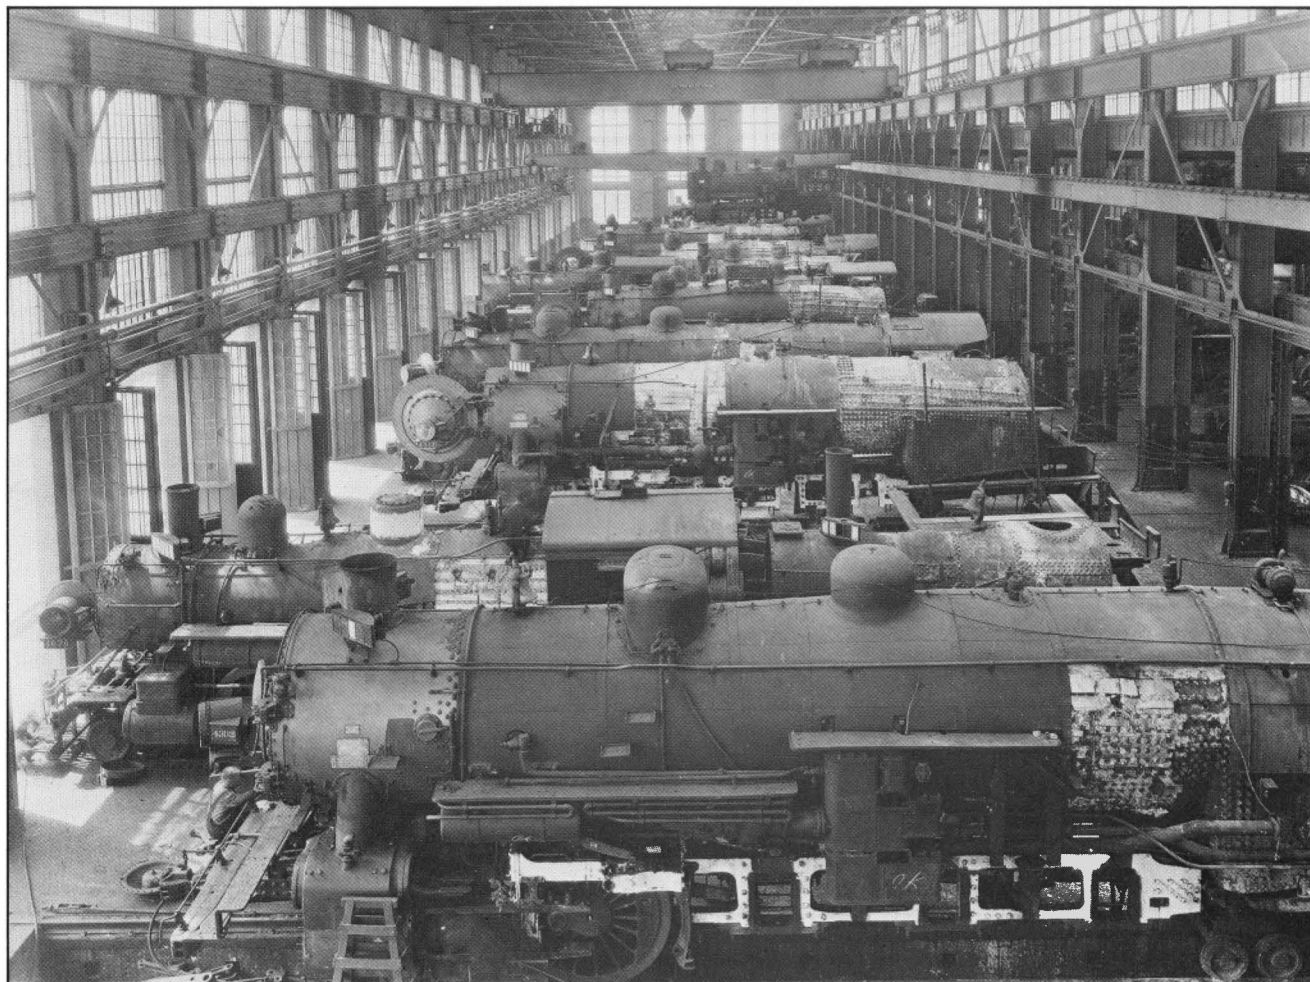
During the days of steam, the Sacramento Shops were a much busier place than what they are today. In this undated photo from Southern Pacific's files, every stall of today's Fabrication Shop was full and 0-6-0 number 1226 was being lifted by the overhead crane.
Southern Pacific

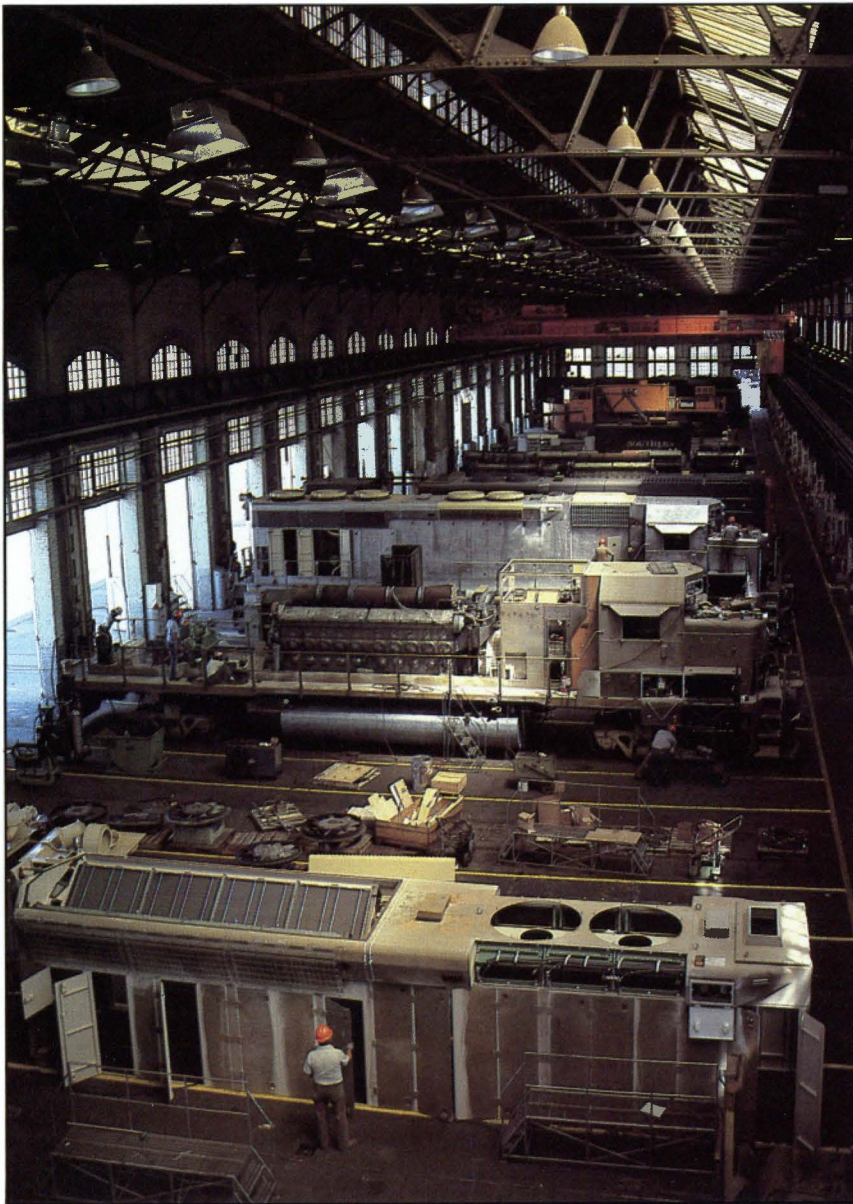
This vantage point from the overhead crane shows an overview of the Erecting Shop in July 1985. The long hood of SD45R 7552 (with new radiators) is in the foreground, the rest of the 7552 is taking shape two stalls away, SD45R 7551 is nearing completion, SD45T-2 9171 is receiving a new main generator, a spreader is having a bent ram replaced, and SD40T-2 8303 is receiving a new prime mover.

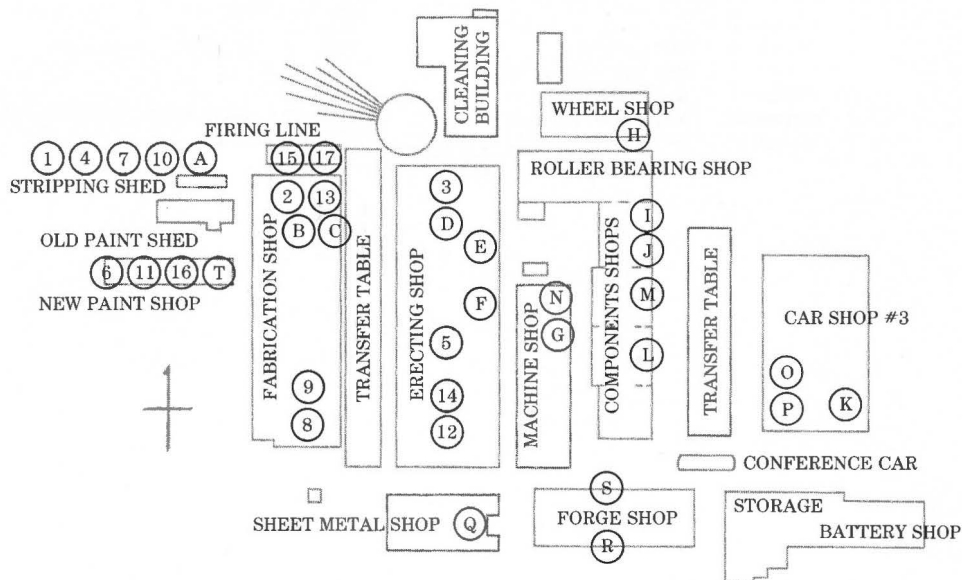
GRIP Location and Operation

1. Stripping Shed —Pre-Clean
2. Drop Pit — Detruck
3. Erecting Shop —Pre-Strip
4. Cleaning Track —Wash
5. Erecting Shop — Final Strip
6. Grit Blast Facility —Grit Blast Exterior
7. Cleaning Track —Wash
8. Fabrication Shop —Pre-Fab Frame
9. Fabrication Shop —Pre-Fab Hood
10. Cleaning Track —Wash
11. Paint Facility —Primer
12. Erecting Shop —Rebuild
13. Drop Pit — Retruck
14. Erecting Shop — Finish Rebuild
15. Firing Line — Test
16. Paint Facility — Final Paint
17. Firing Line — Final Test and Release

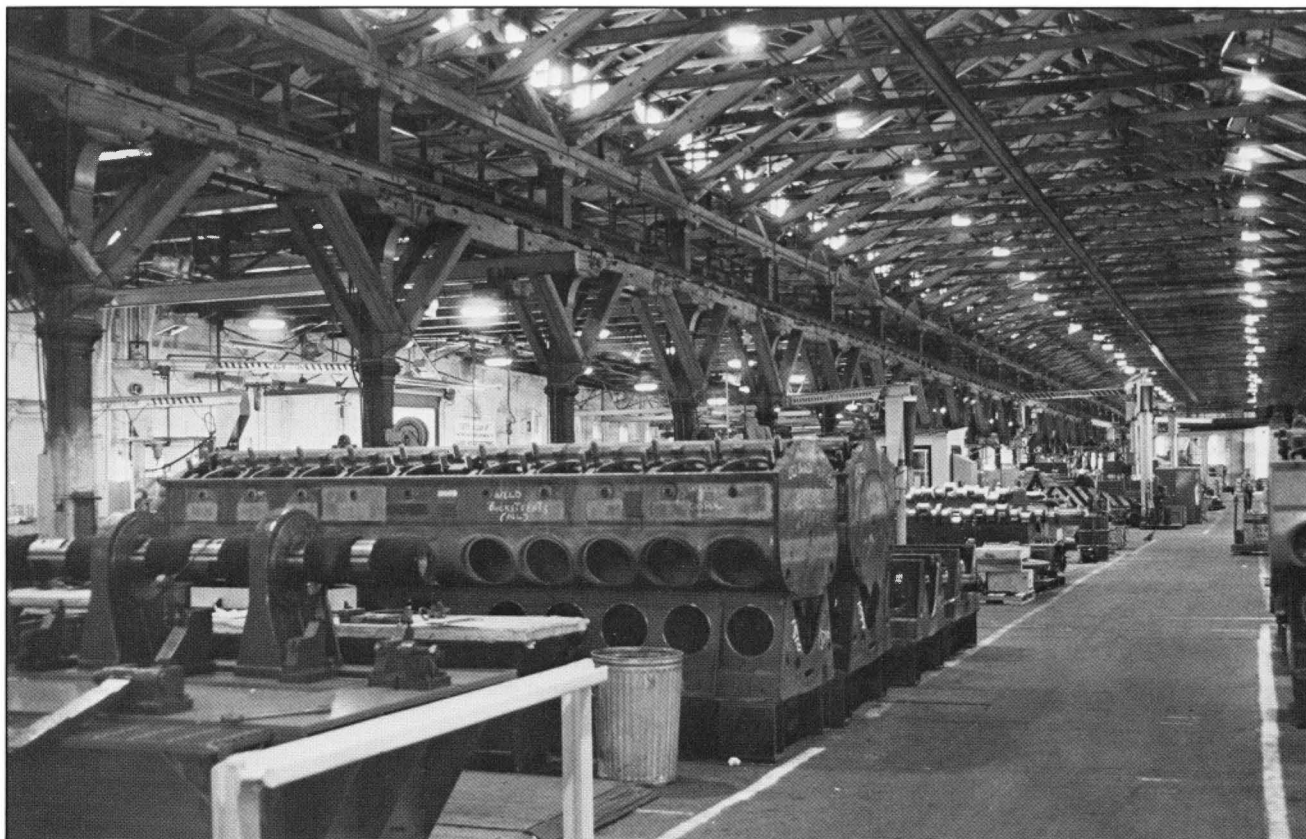
This is a general overview of the prime mover rebuilding area located in the Erecting Shop. In the foreground, valve camshafts, next are two 20-cylinder 645 engine blocks and in the background are crankshafts.

Perhaps one of the more interesting tasks the shop performs to the outside observer is in inspecting the engine blocks before rebuilding. The 20-cylinder block is exceptionally long, and after several hundreds of thousands of miles of use, it may develop a slight sag which allows for uneven wear within the engine or a broken crankshaft. When inspecting the the engine blocks, they are set on end-grain oak blocks on the largest granite surface plate west of the Mississippi River and are measured for trueness, the plate being optically flat to within 5/10,000th of an inch. If an engine block is found to be outside of allowable tolerances, the block is line-bored back to specifications.

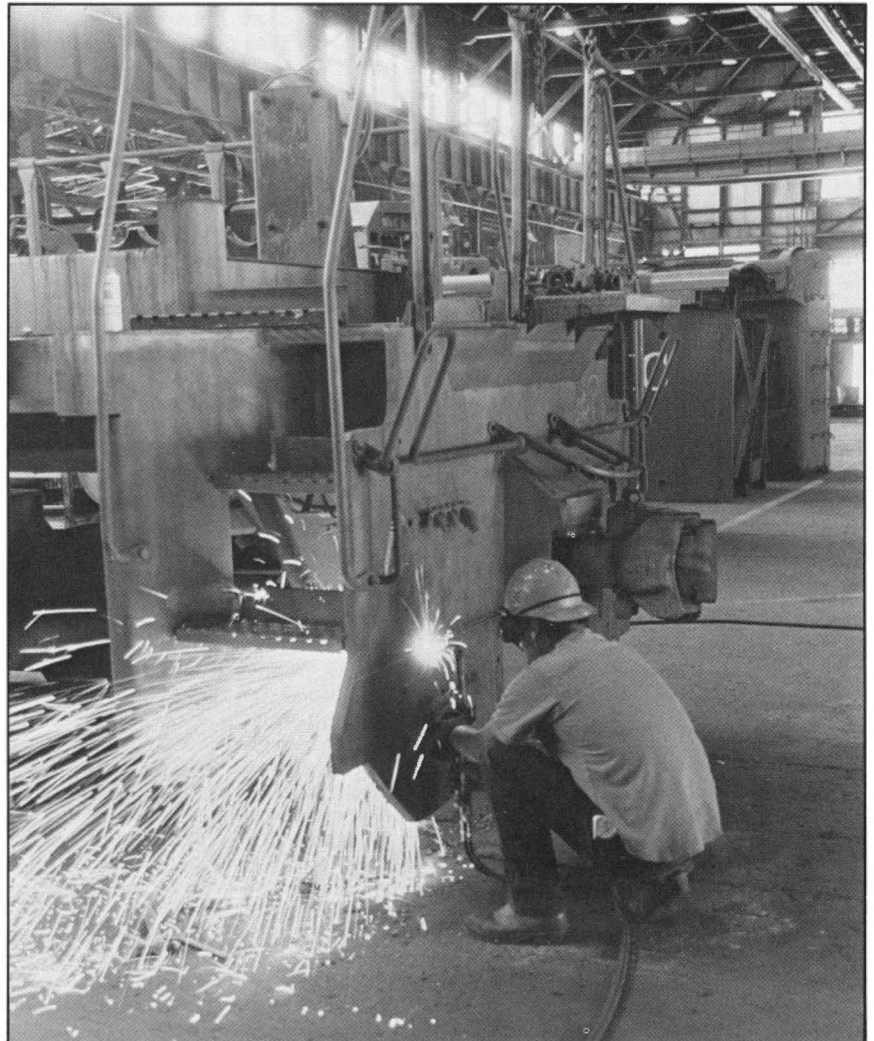
During the rebuilding process SD45R 7553 was receiving a new pilot wind-sheet in the Fabrication Shop. As is always the case, quality is stressed and any damaged parts are repaired or replaced resulting in a new locomotive at the end of the rebuilding process.

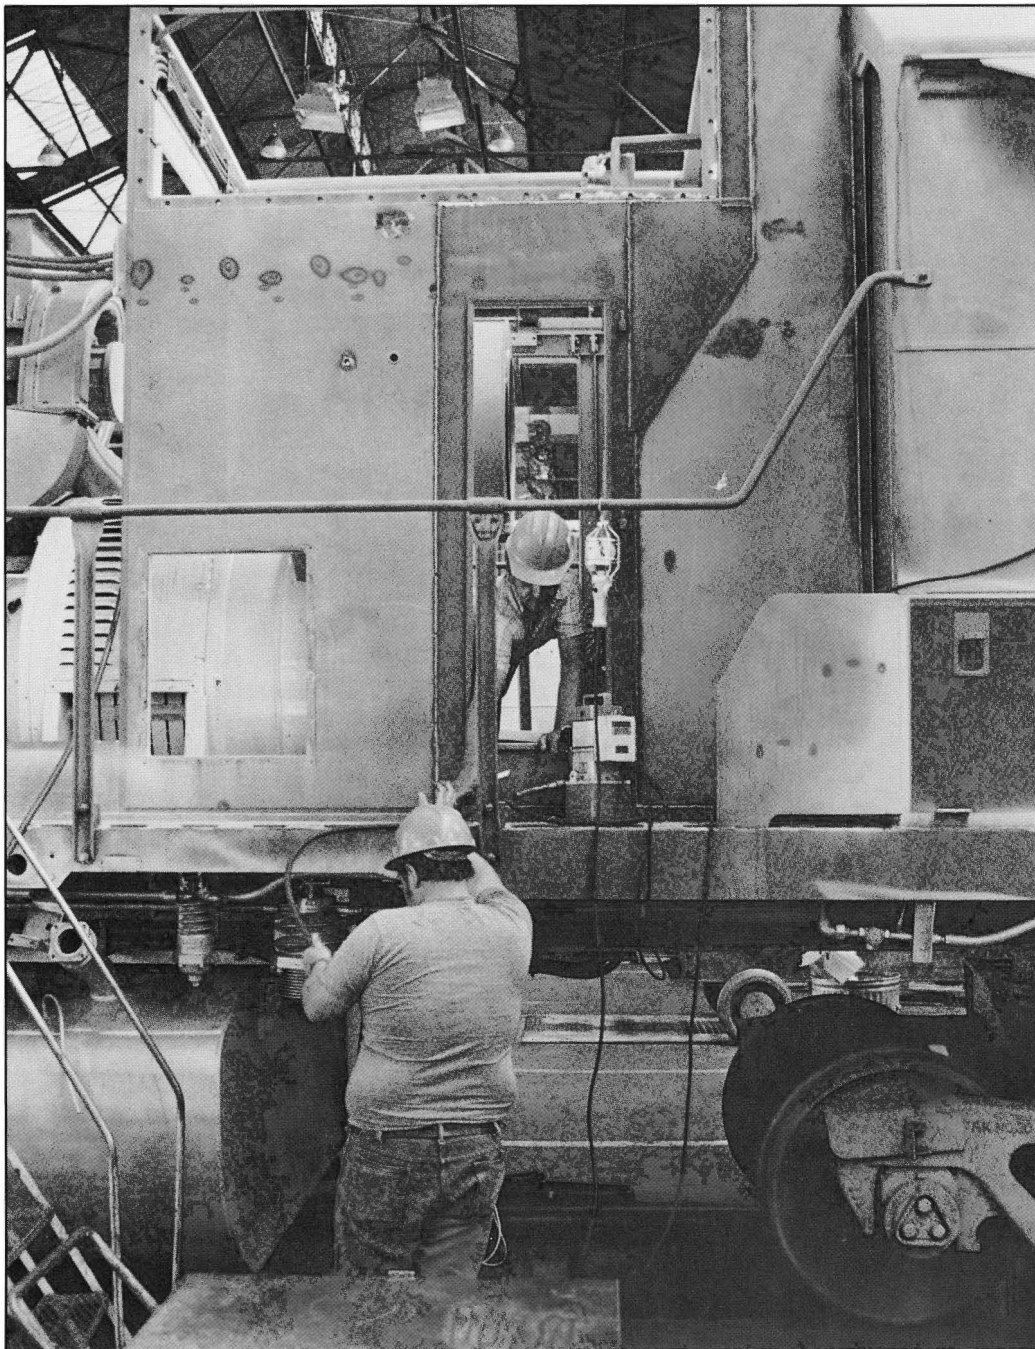
SD45R 7552 was near the mid point in the rebuilding process when photographed in July 1985. The prime mover and main generator were in place as was the new electrical cabinet and workers were in the process of installing the electrical system wiring.

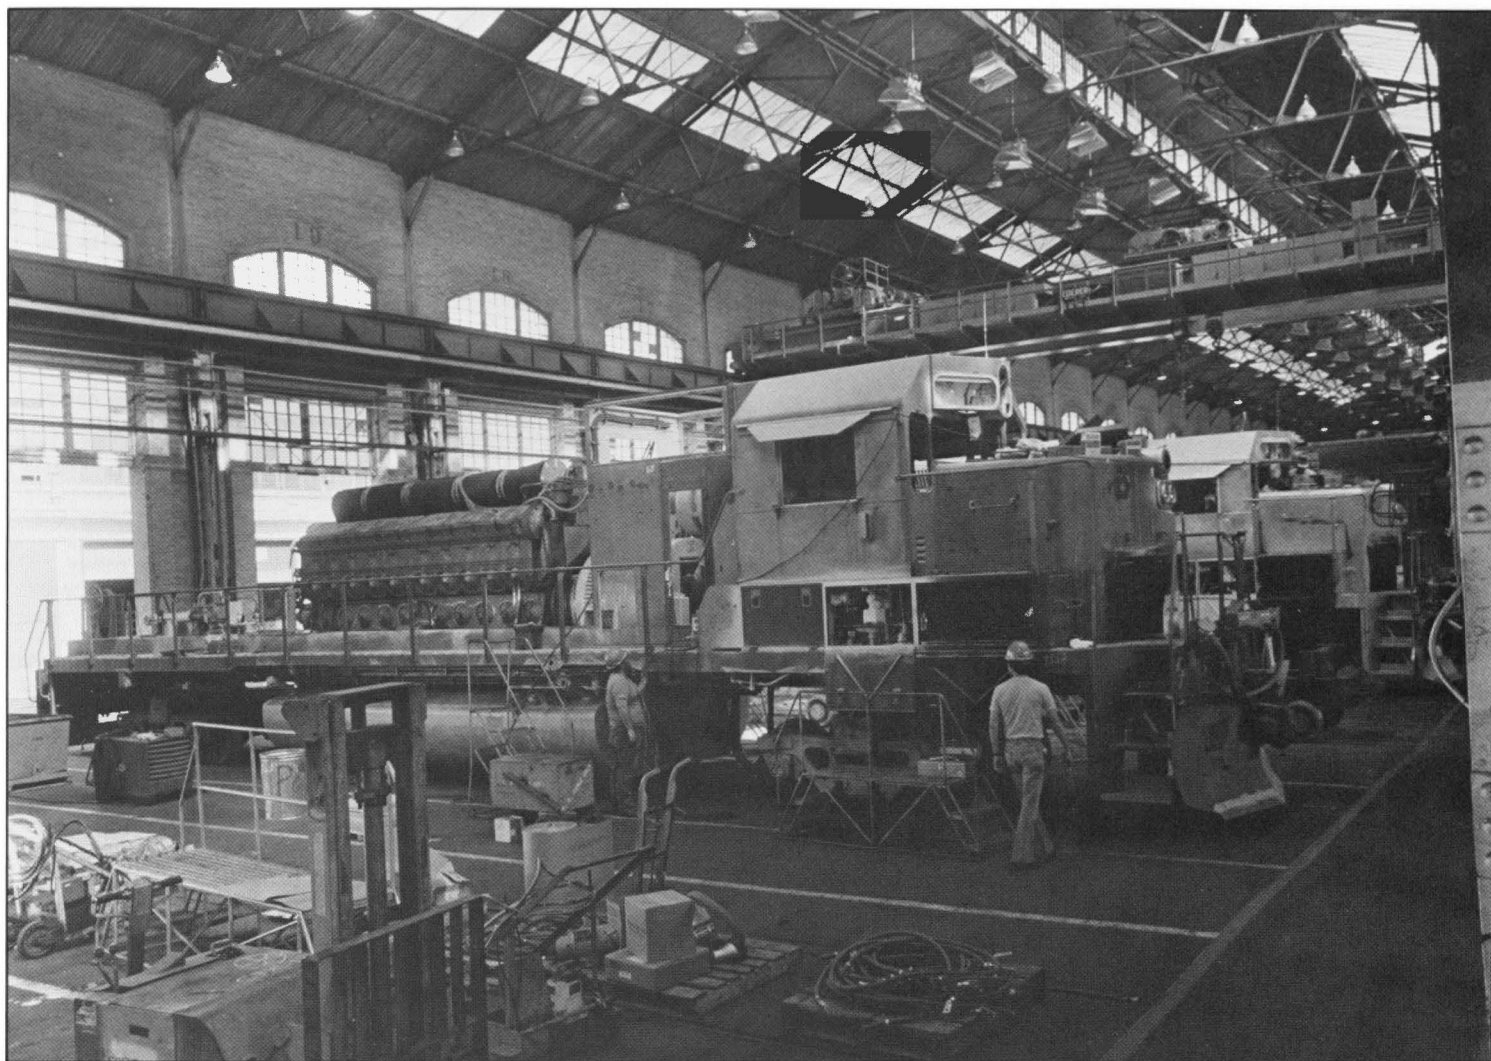
Final assembly takes place in the Erecting Shop where SD45R 7552 was being fitted with electrical components in July 1985. Behind the 7552 is the 7551 which would later become the first SP unit to wear the post merger red and yellow paint.

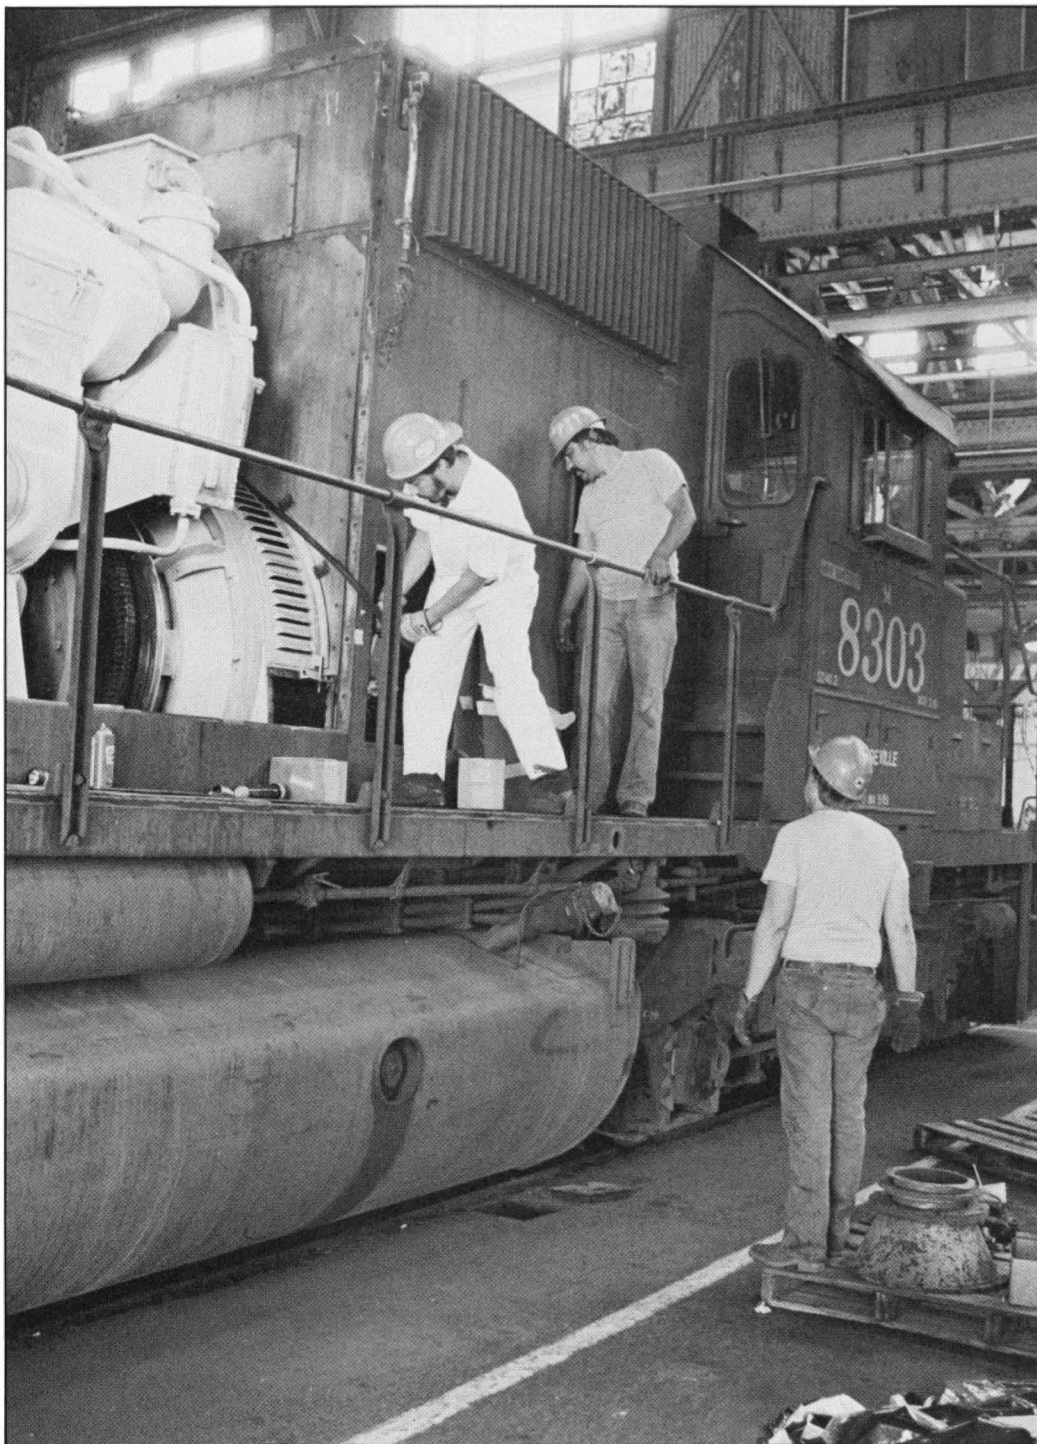
Sacramento does more than rebuild locomotives. They also do a variety of major repairs as was the case when SD40T-2 8303 paid a visit in July 1985 for a new prime mover. This type of heavy repair work is performed in the Erecting Shop.

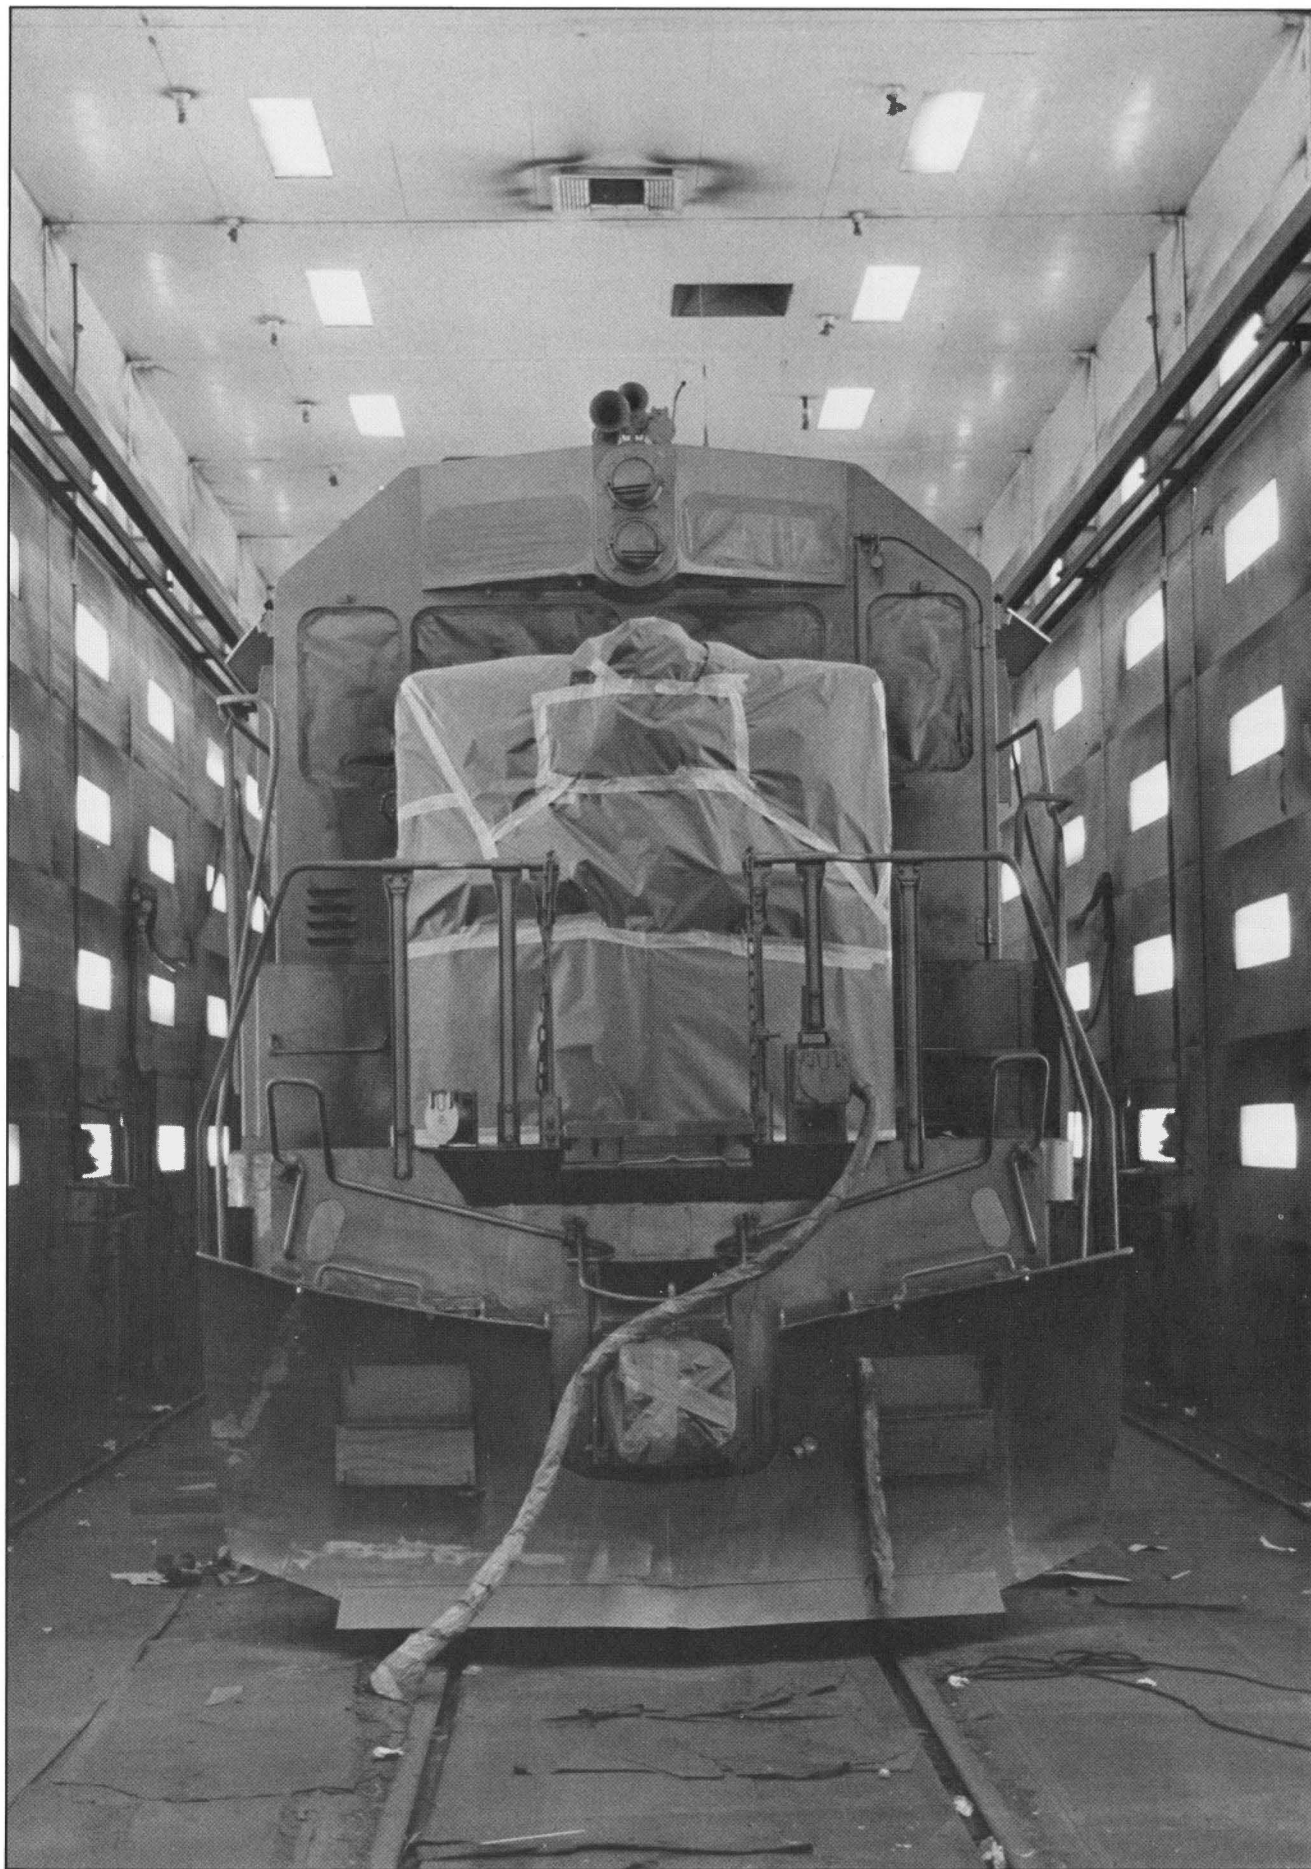
Sacramento paints their locomotives in an environmentally controlled paint shop using the newest in painting technology. Painters are fully enclosed in disposable paper "space suits" complete with an outside source of air and work from special hydraulically controlled platforms which move each painter along the sides of the locomotive. From these platforms painters can spray an entire locomotive without having to walk a step. SD45R 7550 has already received its red nose and has been masked off for the coat of traditional SP grey.

The new environmentally-clean paint shop is unlike anything most of us have ever seen, somewhat resembling a scene out of a science-fiction space movie. The painters are encased in white, paper jump suits and wear protective helmets and masks that are connected to an outside air supply. Actual painting is made from a hydraulically operated platform on either side of the locomotive, each individually controlled by the painter.

Painting requires three days for an SD45R unit. The cab and engine room interiors are painted a beige color, a more harmonious and appealing color than the former apple green. On the exterior, the red paint on the rear of the long hood and on the nose are painted first. This is done as it requires far less masking than if the grey areas were painted first. Next comes a coat of dark grey, followed by lettering and numbering, including stenciling of miscellaneous information on com-
